# Manhole Inspection Summary

Manhole # S33I\_\_036MH

Insp Date: **8/13/08 9:48 AM**

**Location** Address: **250 w pratt st**

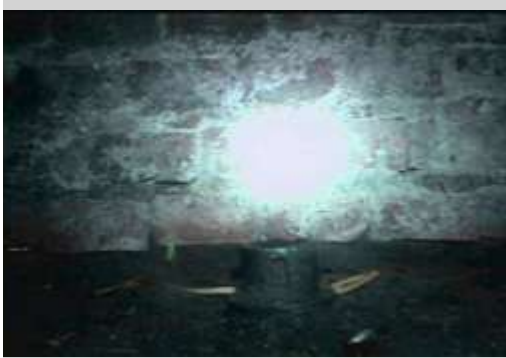
Misc

bench debris

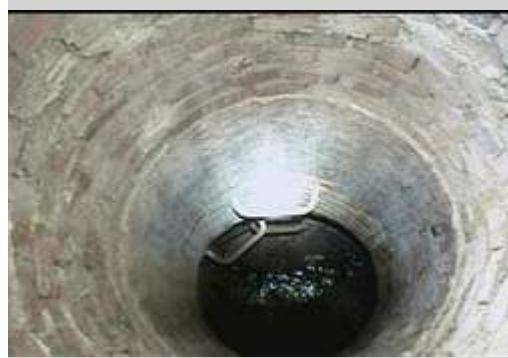
Defect 3

Count: **3** Missing: **0** ☒ **Corroded**

corroded steps

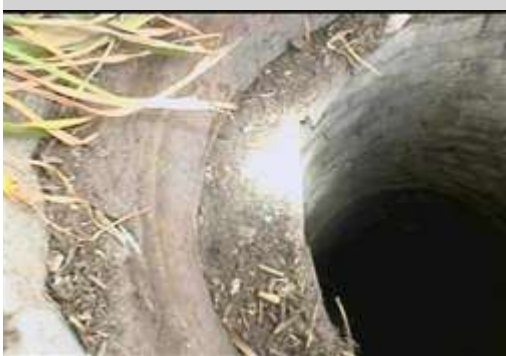
Defect 2

Offset: **5** (in.)

offset

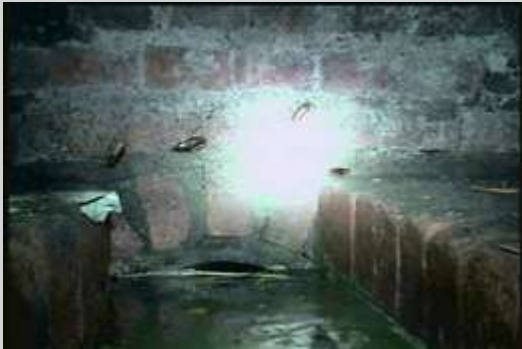
12 O'Clock Outflow

21 in. Circular Gravity Sewer  
Pipe Out @ 12 O'Clock

cant see pipe diameter
